## Resolving Air Gap Leak From RO Faucet

# Resolving Air Gap Leak

(For DLA-12 Type Drain Line Adapter)

## Resolving Air Gap Leak (For Saddle-Clamp Type Drain Line Adapter)

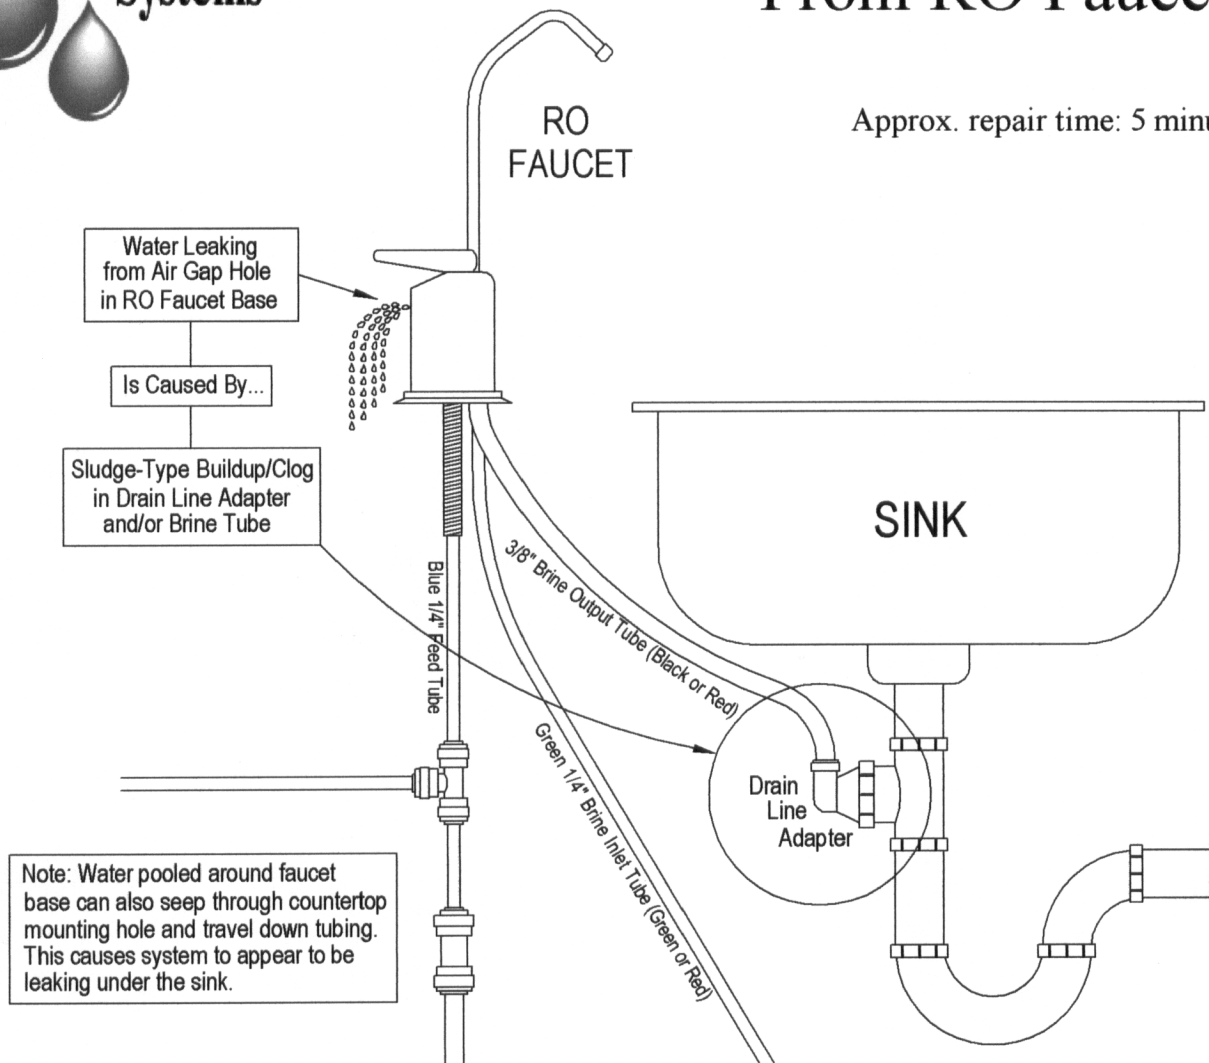
During the production of permeate water, a Reverse Osmosis water system rinses the removed contaminants (brine) via the Brine Output Tube to the drain pipe of the sink. If unable to escape through the sink drain pipe, this brine water will back up and escape the system through the Air Gap Hole located on the back of the Air Gap Faucet.

Through the course of time, ANY sink drain plumbing is susceptible to a bacteria generated sludge-type buildup that can occur - forming a complete blockage of the brine water disposal pathway.

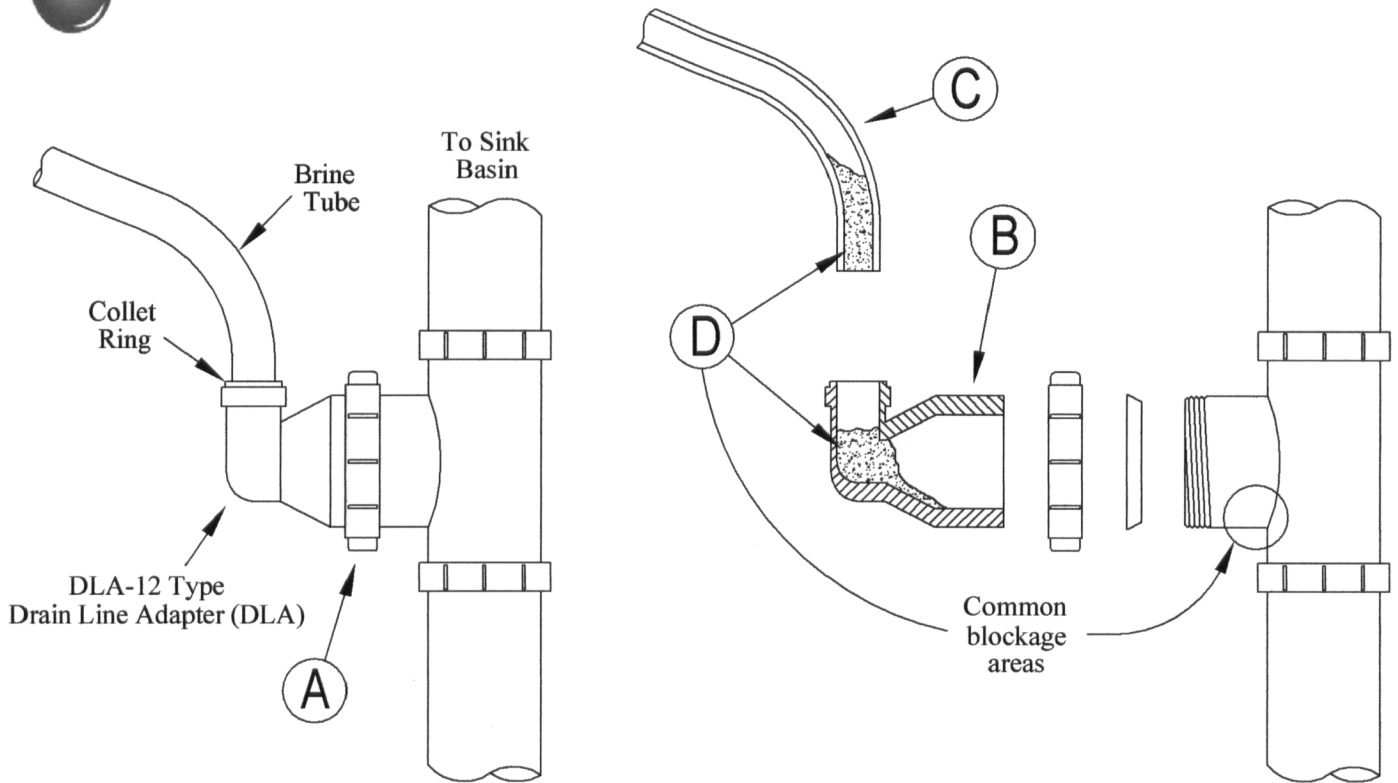
2) Loosen large collar nut securing DLA-12 to drain pipe. (See "A")

3) Remove DLA adapter cup from sink drain pipe. (See "B")

4) Remove Brine Tube from DLA fitting. (See "C")

1) Turn Tank Valve handle on top of 3 gallon reservoir tank to the "OFF" position.

(Rotate blue valve handle 1/4 turn so it is perpendicular to tube going into valve)

\*Locate the collet ring at point where tubing connects into fitting. Push & hold collet ring down while pulling tube out in opposite direction.

5) Clean out all clogging debris (See "D") using paper clip, knife blade, or other small tool

6) Reconnect Brine Tube into fitting. (Ensure DLA-12 90° opening is vertical)

7) Turn Tank Valve handle back to "ON" position.

(Rotate blue valve handle 1/4 turn so it is parallel or in-line with tube going into valve)

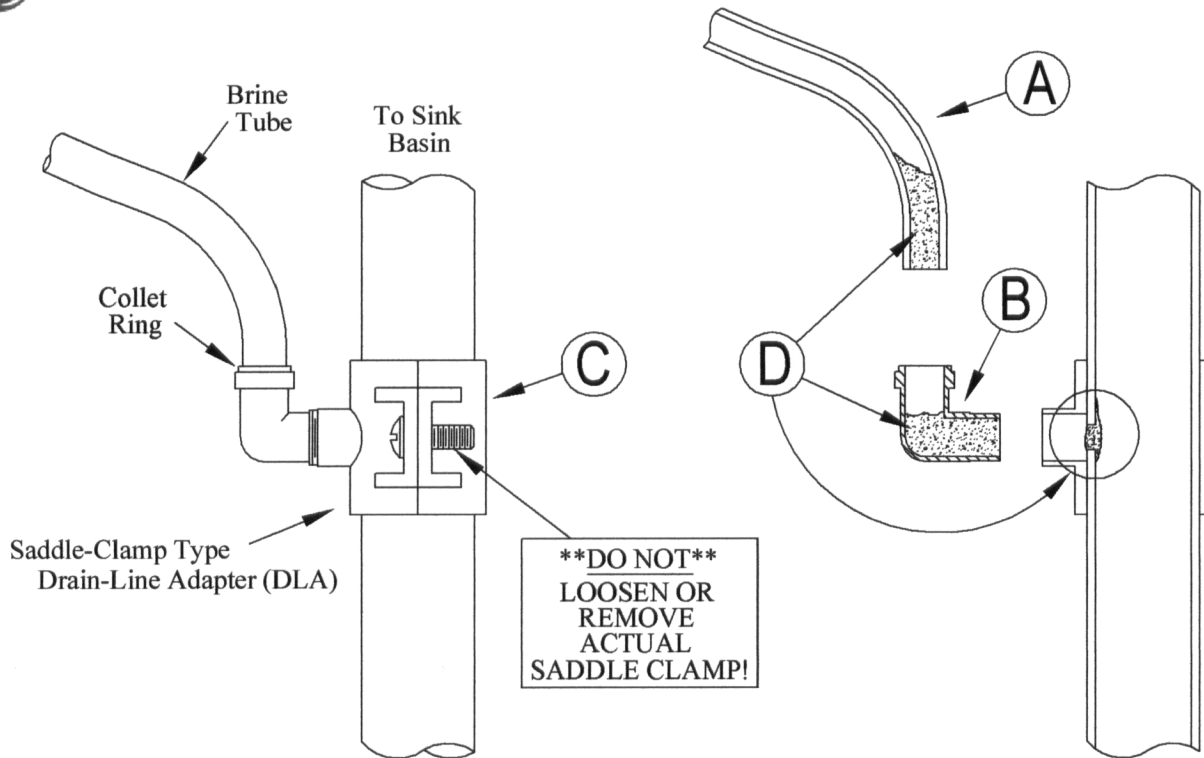
2) Remove Brine Tube (See "A") from 90° fitting (See "B").

3) Using adjustable wrench, remove 90° fitting (See "B") from Saddle Clamp on drain pipe

\*Do not loosen or remove Saddle Clamp Assembly yoked around drain pipe! (See "C")

1) Turn Tank Valve handle on top of 3 gallon reservoir tank to the "OFF" position.

(Rotate blue valve handle 1/4 turn so it is perpendicular to tube going into valve)

\*Locate the collet ring at point where tubing connects into fitting. Push & hold collet ring down while pulling tube out in opposite direction.

Push Here on Collet Ring

4) Clean out all clogging debris (See "D") using paper clip, knife blade, or other small tool

5) Reconnect Brine Tube into fitting. (Ensure 90° fitting opening is vertical)

6) Turn Tank Valve handle back to "ON" position.

(Rotate blue valve handle 1/4 turn so it is parallel or in-line with tube going into valve)

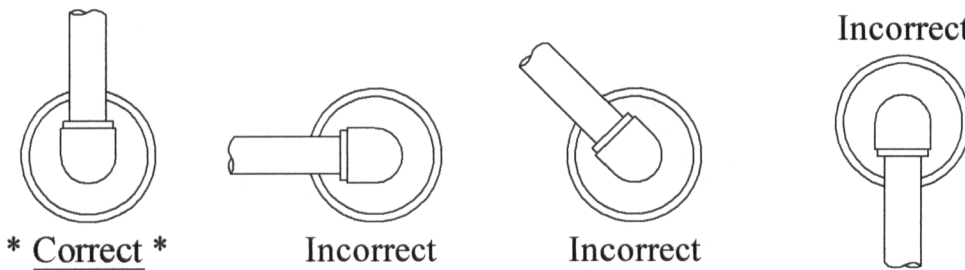
Frontal view of Drain Line Adapter & inserted Brine Output Tube:

Step 2: Ensure Brine Output Tube enters Drain-Line Adapter (or 90° fitting) vertically:

Step 1: Make sure no dips, sags, or loops reside in Brine Output Tube
